**ELLIS ISLAND
STATUE OF LIBERTY NATIONAL MONUMENT**

**HISTORIC STRUCTURE REPORT
POWERHOUSE**

Volume 3

**Beyer Blinder Belle/
Anderson Notter Finegold**

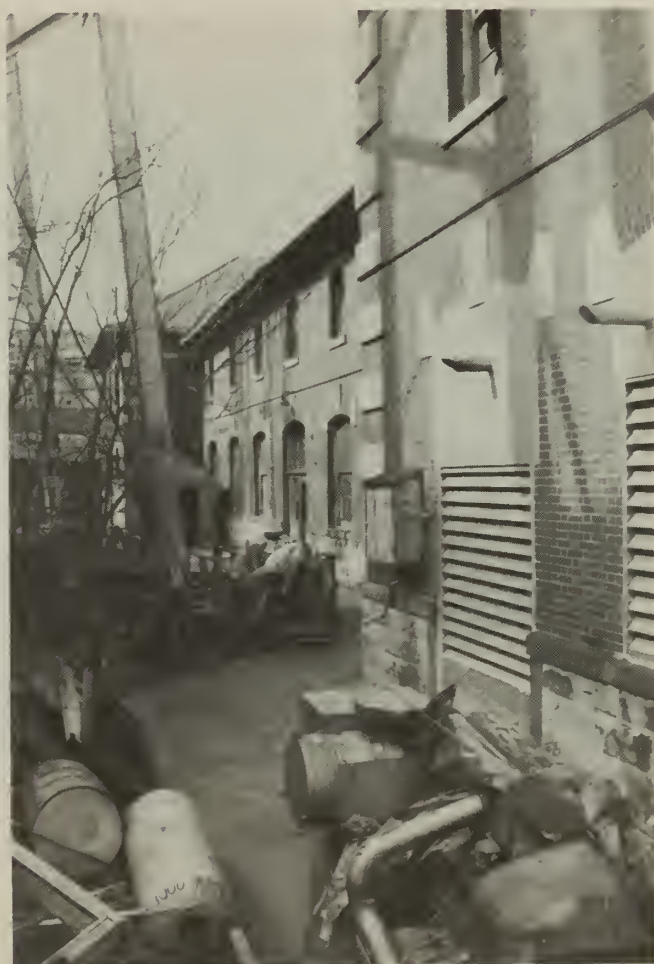
18). One entrance on the east facade has been replaced with louvered vents (photo 2). Two doorways on the east elevation have been filled in with brick (photo 19); one of these has a small four-over-four window. All existing doors, with the exception of those at the northeast entrance, are not original.

2. East elevation, view southwest.

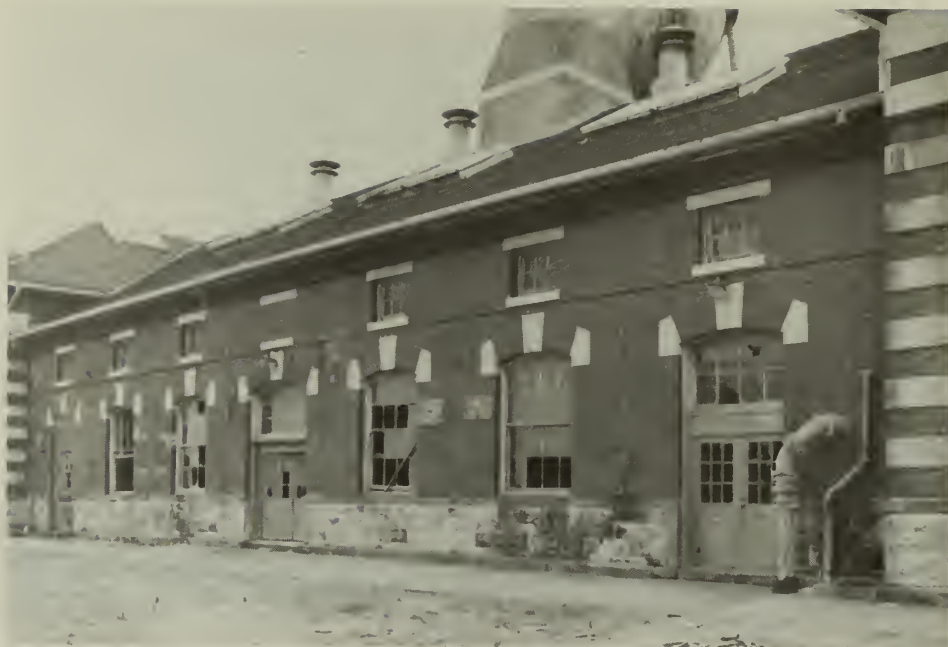
Wood window enframements are in poor condition and are not reusable. Most window sash is splitting and warped. Muntin joints are open and much of the glazing is broken or missing (photos 1, 4, 7, and 36). Several of the dormer windows are no longer extant and have been filled in with plywood.

7. West elevation, view northeast.

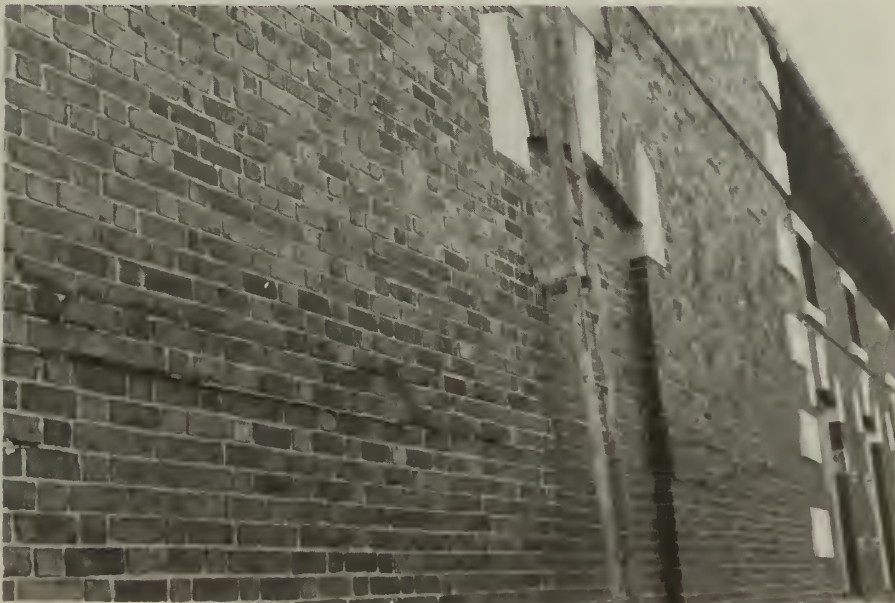
22. Heaving brick courses at northwest corner.

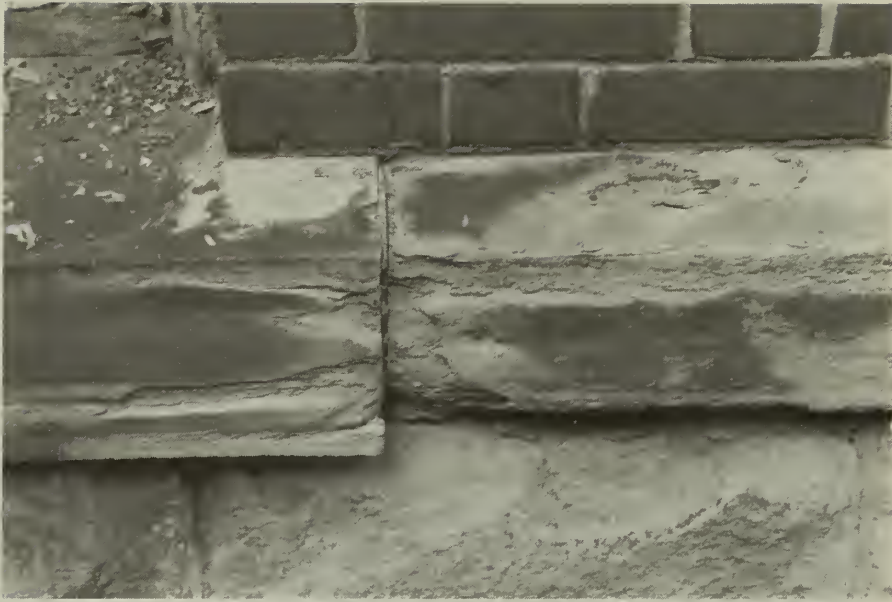
23. Exfoliation, bluestone water table, east elevation.

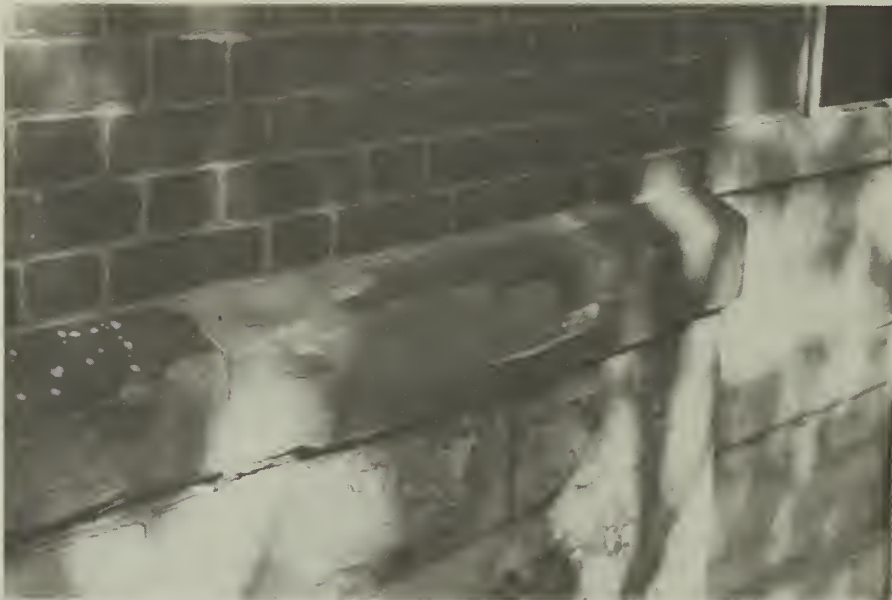
24. Exfoliation, bluestone water table, east elevation.

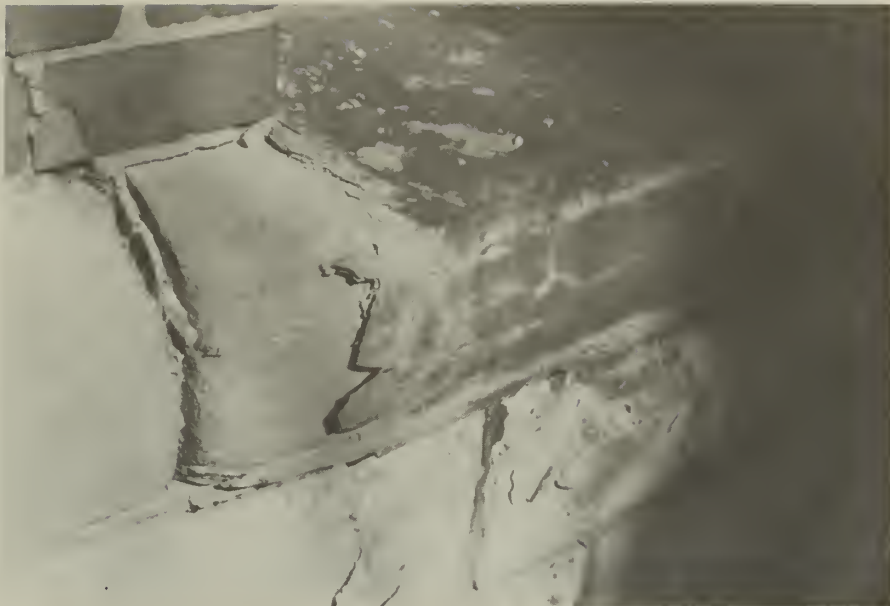
25. Exfoliation, bluestone water table, east elevation.

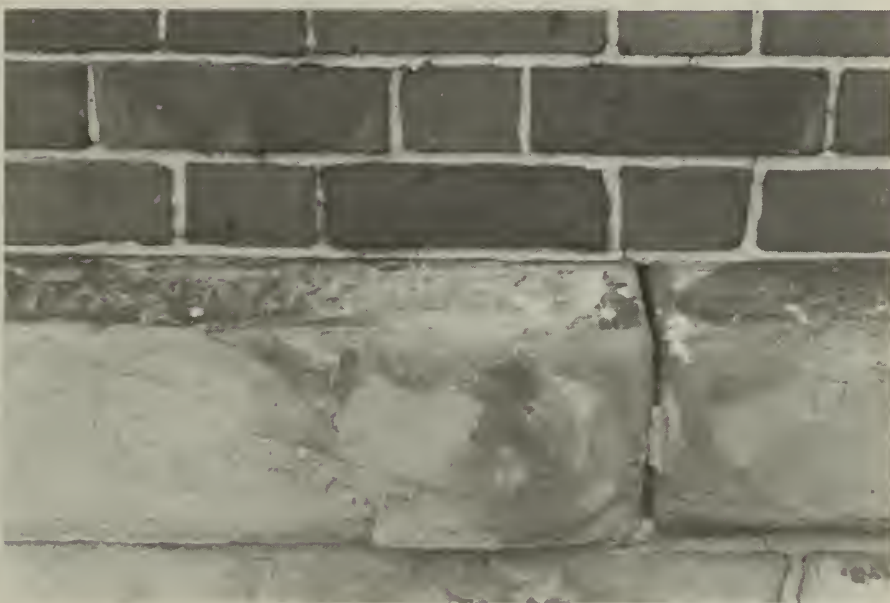
26. Exfoliation, bluestone water table, west elevation.

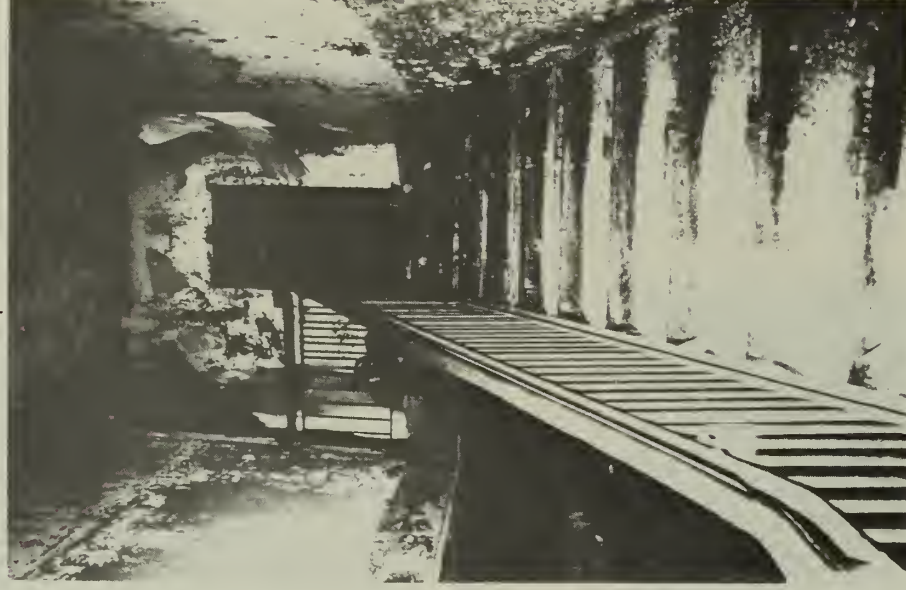
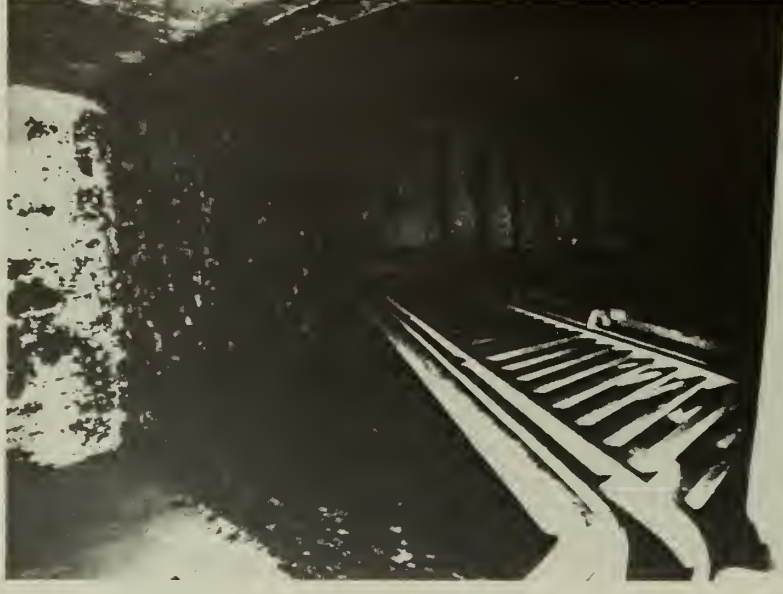
PHOTOGRAPHS: (1) FROM FIRST FLOOR LANDING (2) FROM PLATFORM (3) FROM TOP LANDING ROOM NO. 501

General: All ironwork, surface corroded. Balustrade corroding at bases. All metal surfaces badly flaking paint and corroded.

Floor: Generally good. First floor landing tile cracked and floor sagged at center.

Ceiling: Fair. Peeling paint and plaster spalling. Exposed lath in northern corner.

Lighting: Missing shades.

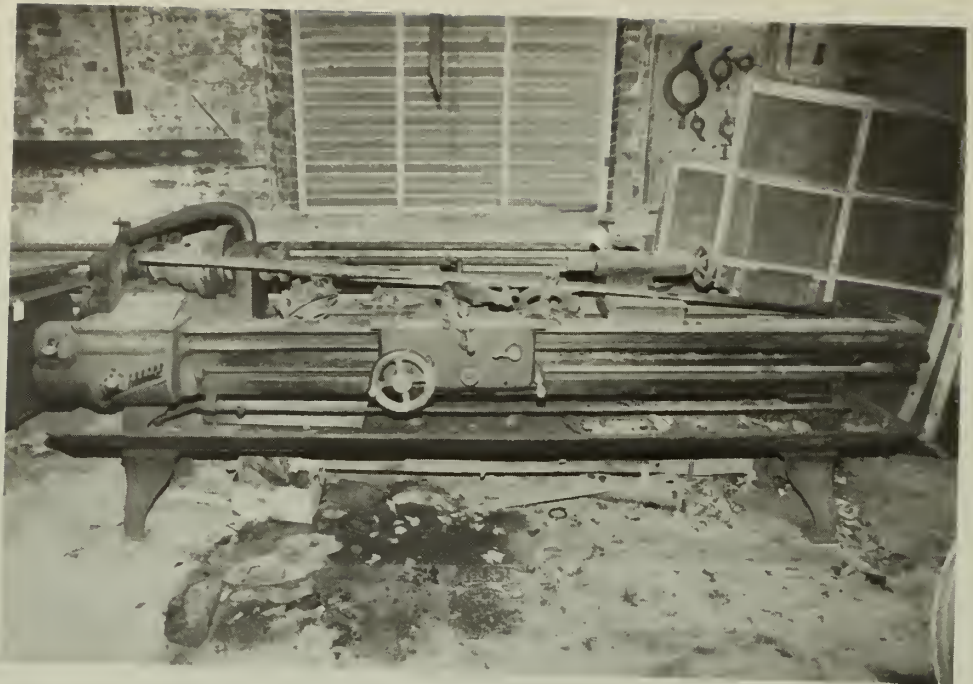
66. Room 108- Belt-driven lathe, (#2)

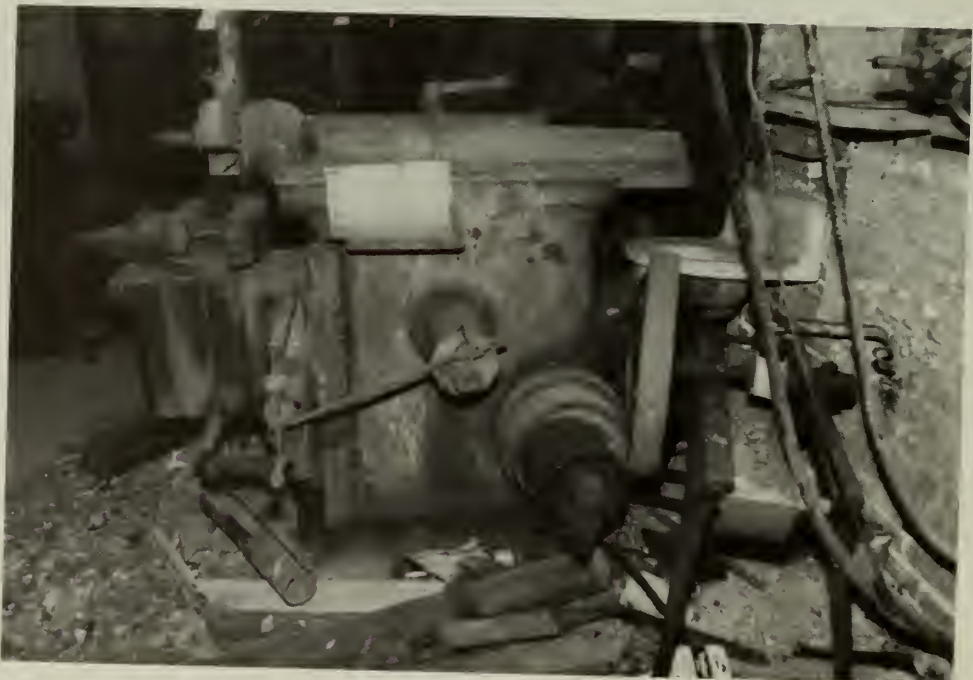
67. Room 108- Unidentified, (#3)

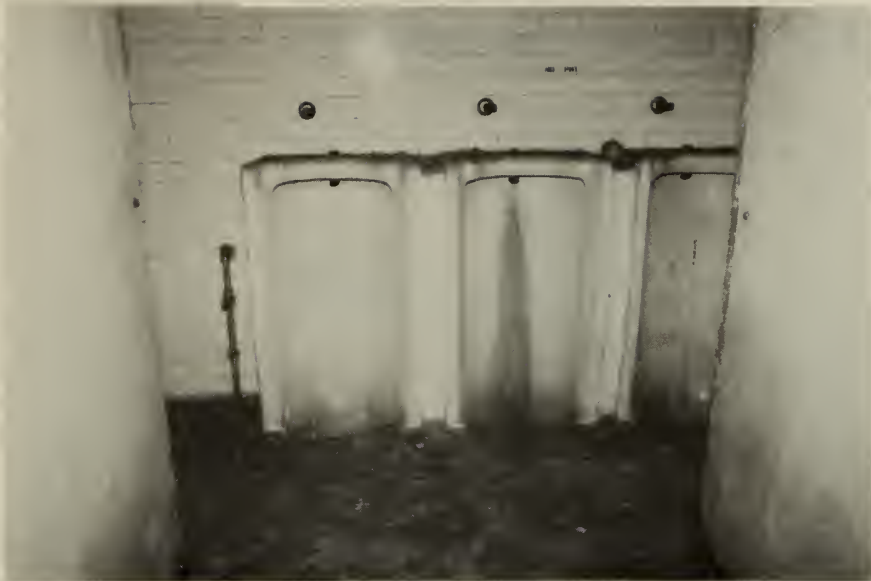
The fixtures in the powerhouse are primarily limited to the second floor. On the first floor, there is only one slop sink located at the west wall of the boiler room. On the second floor, there are three toilets, one shower/wash room, two room sinks, and two aluminum enclosed showers. All fixtures date from the 1930's or later (photos 3-6).

3. Room 212, floor-type urinal.

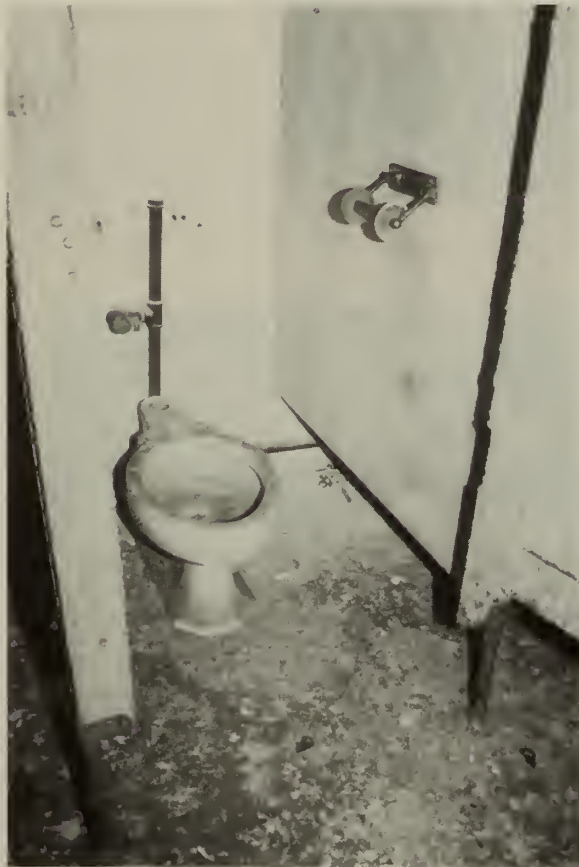
4. Room 212, toilet.
